UNDERGROUND INJECTION CONTROL
INSPECTION REPORT

Purpose: Permit Compliance Evaluation

Facility: SWD Specialties, LLC of Kalkaska, Michigan;
Hogerheide #1-29 SWD,
Wlosinski #2-27 SWD, and
Simpson #1-9

EPA UIC Permit Number(s): MI-079-2D-C001
MI-079-2D-C016, and
MI-079-2D-C008

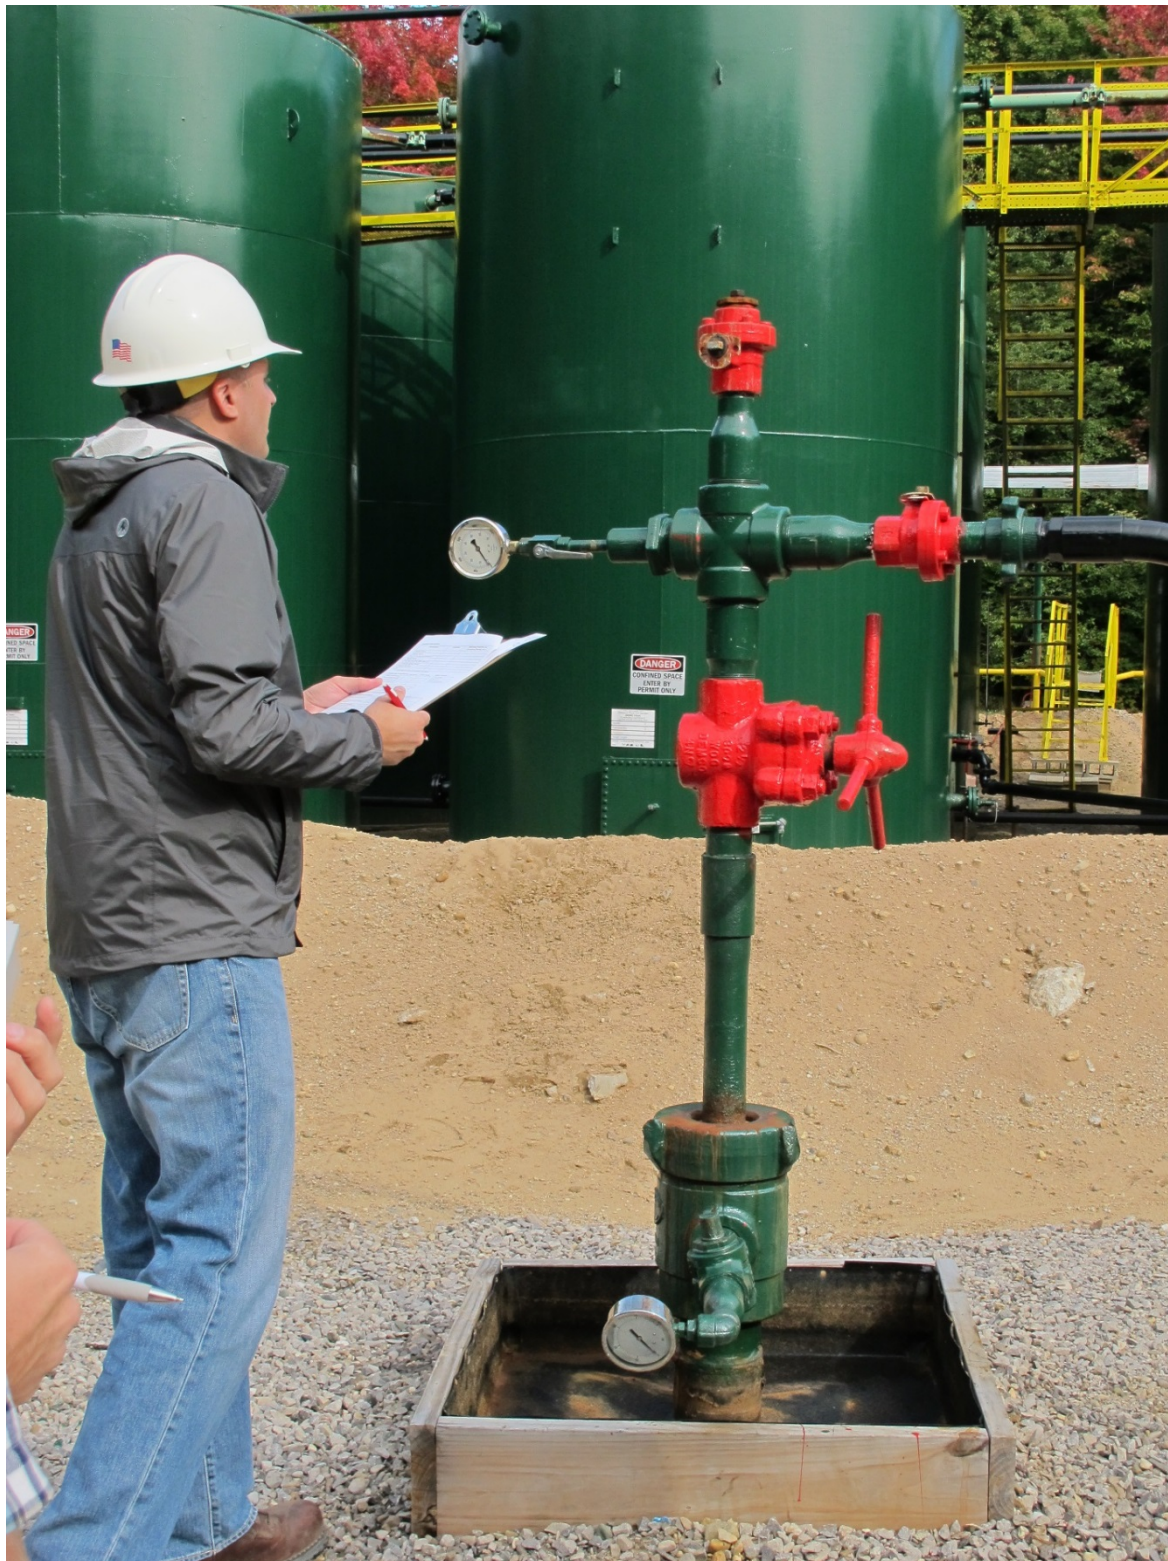
Figure 18: IMG_0277, 9/25/14, 11:14 am (Eastern), Simpson #1-9 wellhead, tank battery and secondary containment areas, EPA Inspector Tim Elkins observing tubing gage and well conditions, facing north.

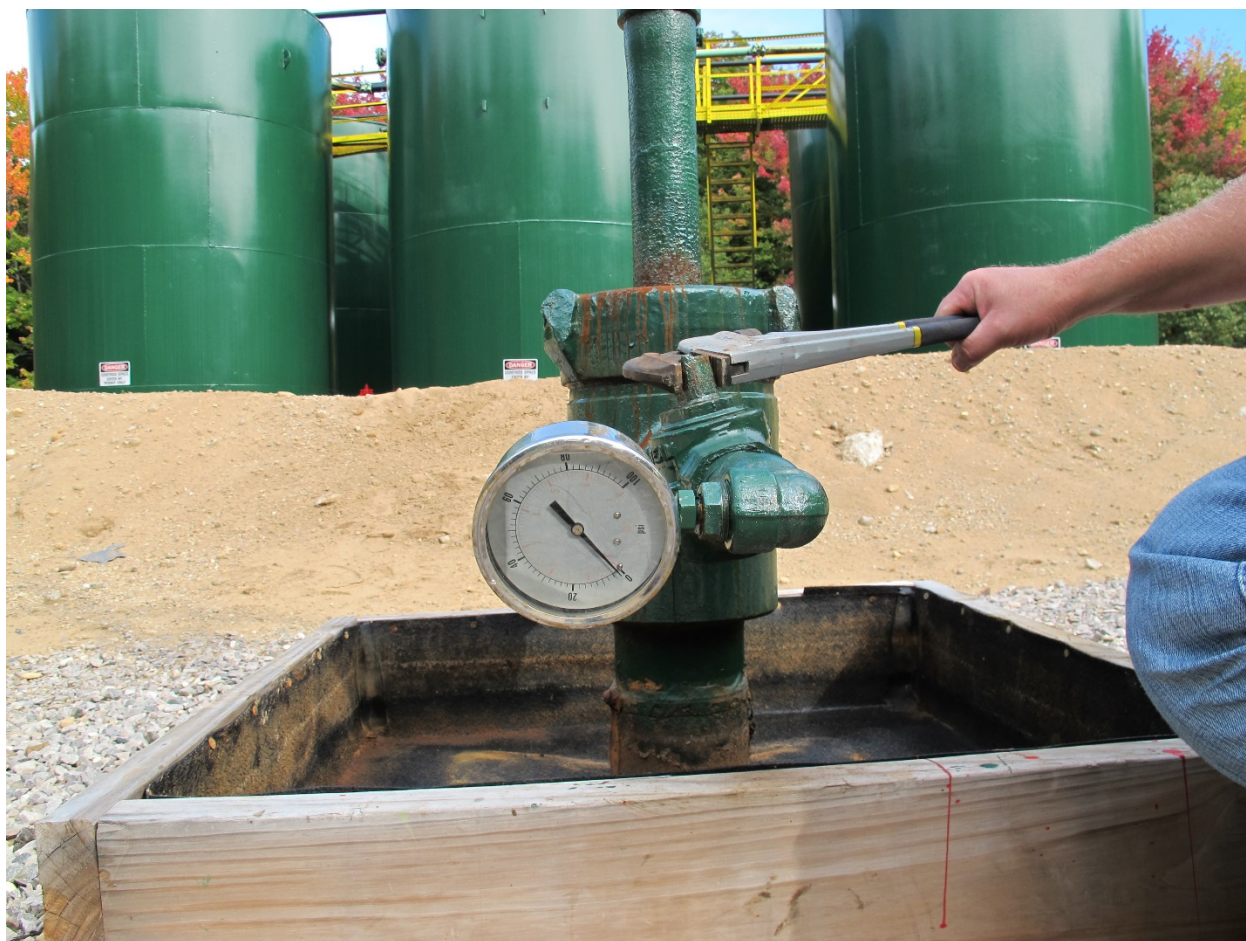
Figure 20: IMG_0279, 9/25/14, 11:16 am (Eastern), Simpson #1-9 annulus gage (1 - 2 psig observed with valve open to gage), tank battery and secondary containment areas, facility representative pictured (right) opening the valve to the annulus gage, gage appeared in good working condition, facing north.

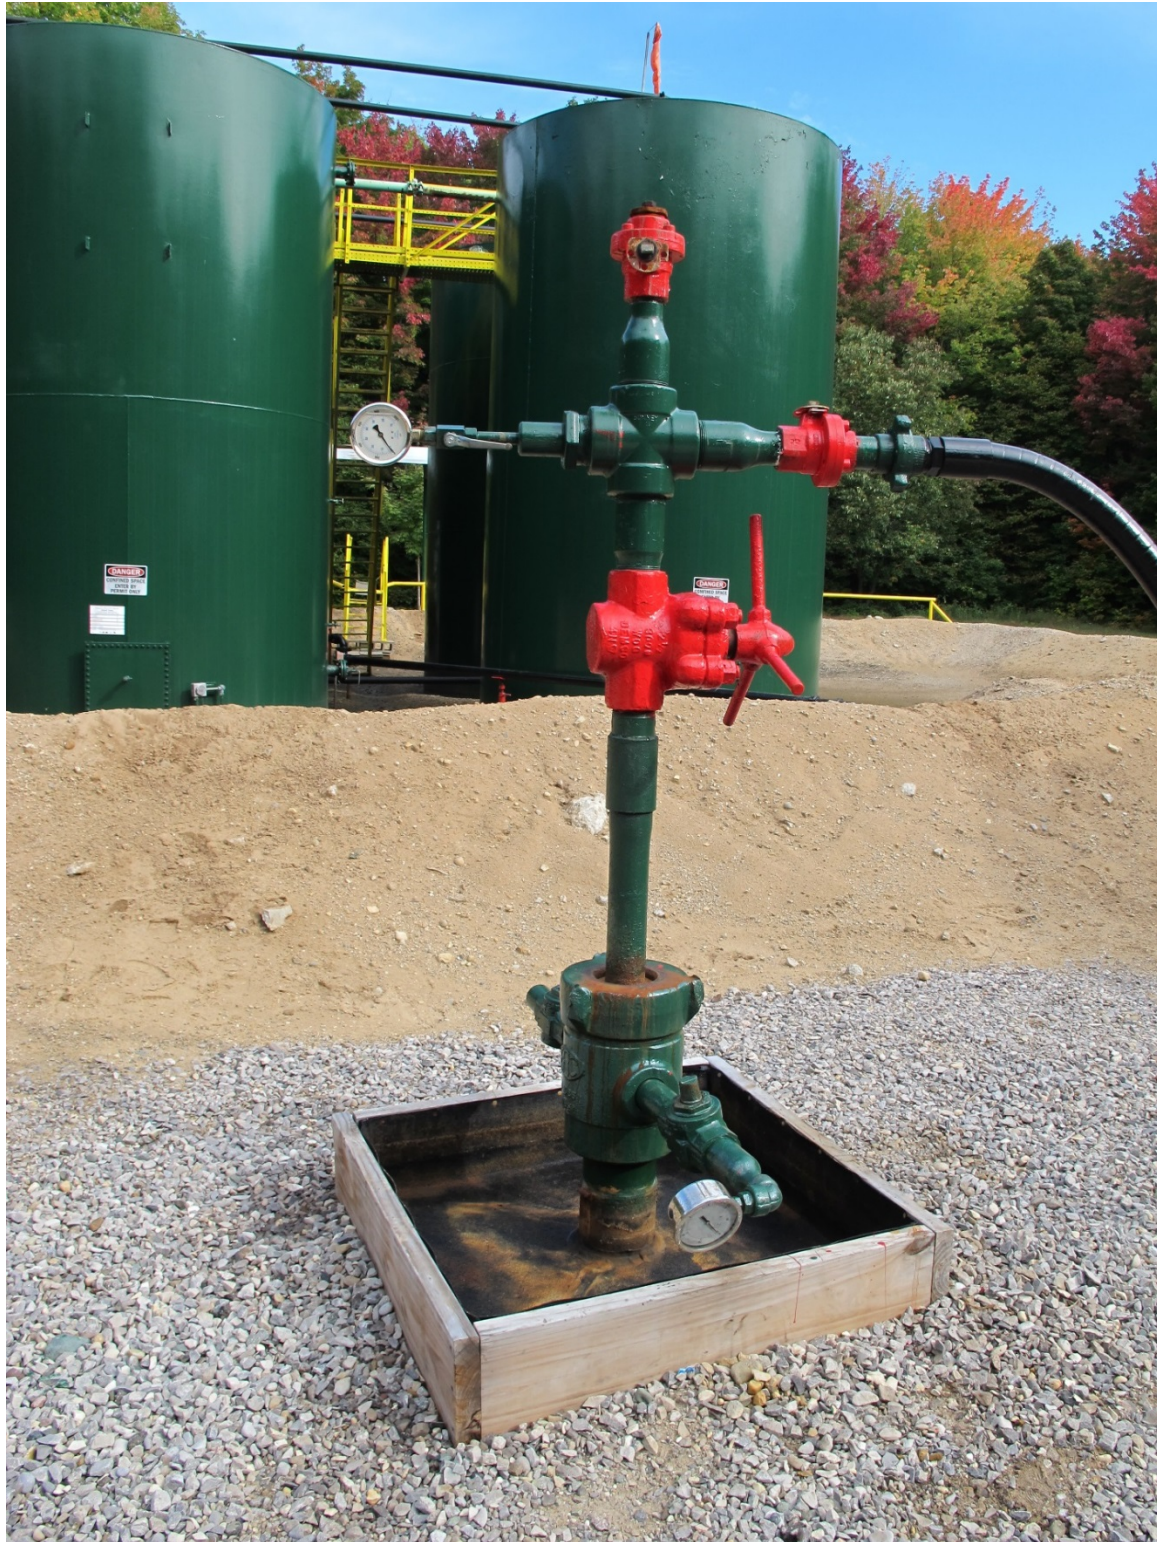
Figure 21: IMG_0280, 9/25/14, 11:16 am (Eastern), Simpson #1-9 wellhead and tank battery, well pad and secondary containment areas appeared in good condition, no signs of spills or leaks were present, facing northeast.

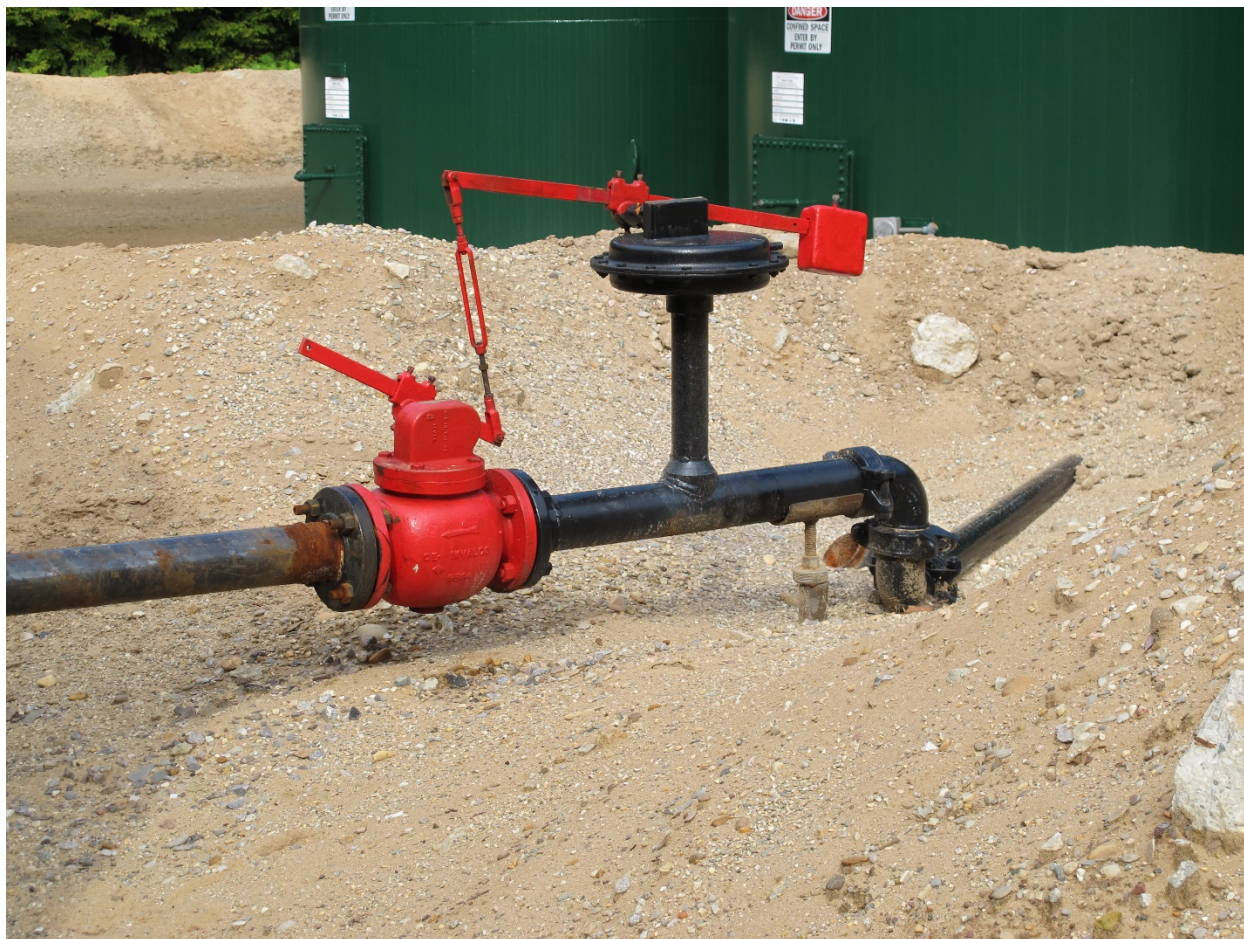
A Murphy Pressure Switchgauge controls injection pressure at the site, and a Kimray liquid level control valve, or “dump valve” opens when fluid in the storage tank rises above a set level. These control devices are common in salt water disposal systems. MIP is limited to 298 psig at the Simpson #1-9. EPA observed 0 psig on the Murphy Switchgauge located in the pump house while the well was not injecting; the mechanical gage is set to shut down at approximately 275 psig (Attachment B, Figure 23). Mr. Kniss stated that the volume of fluid injected and flow rate are based on the fluid level in the facility’s brine tanks, and all injection and annulus pressure are monitored manually from the facility’s mechanical gages.

Figure 22: IMG_0281, 9/25/14, 11:17 am (Eastern), Simpson #1-9 well pad and tank battery, Kimray liquid level control valve (i.e. "dump" valves) pictured, equipment and secondary containment areas appeared in good condition, facing northwest.

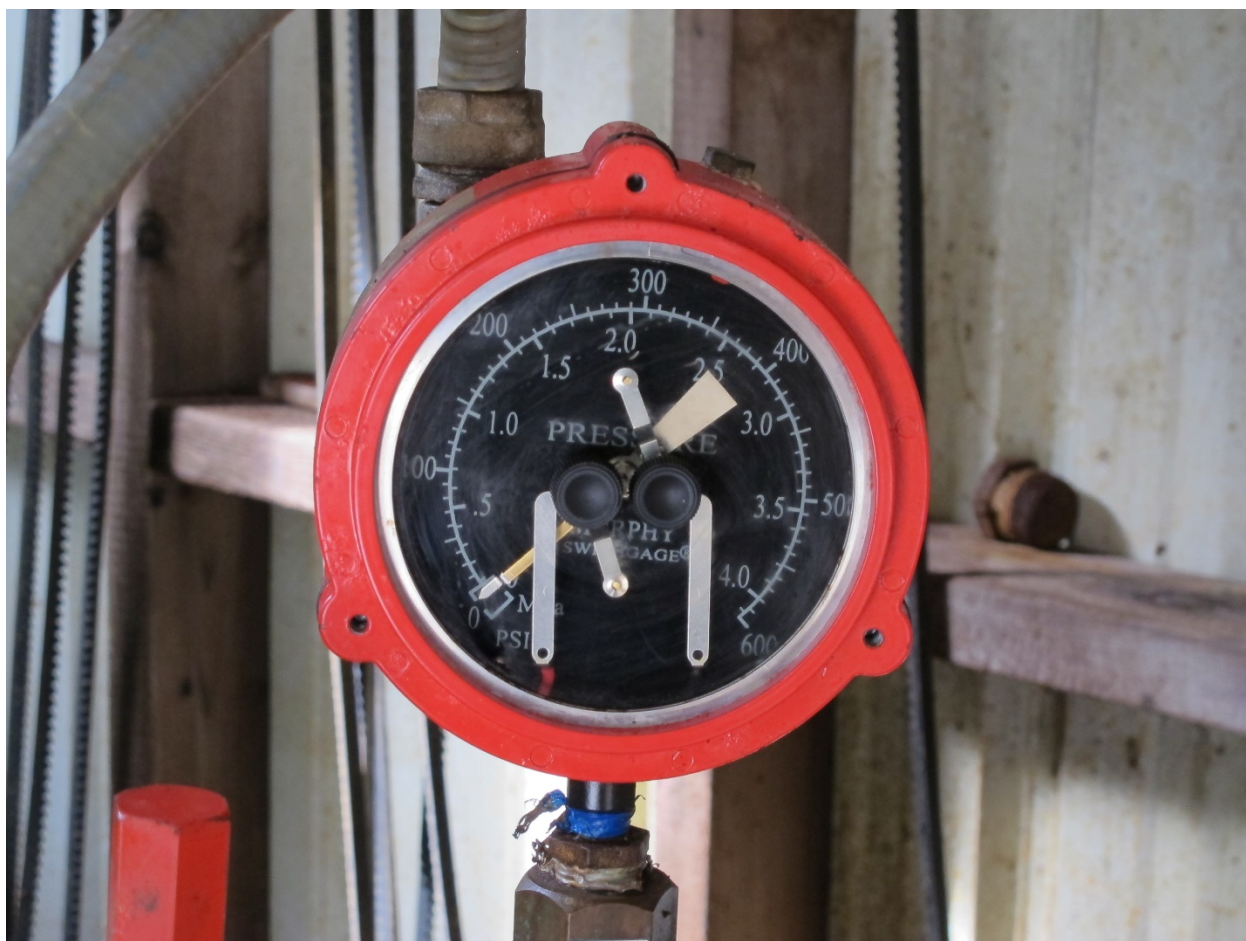
Figure 23: IMG_0282, 9/25/14, 11:18 am (Eastern), Simpson #1-9 facility Murphy Swichgage instrument (mechanical pressure gage) used to start and stop injection, located within the facility pump house, 0 psig observed (well not injecting).

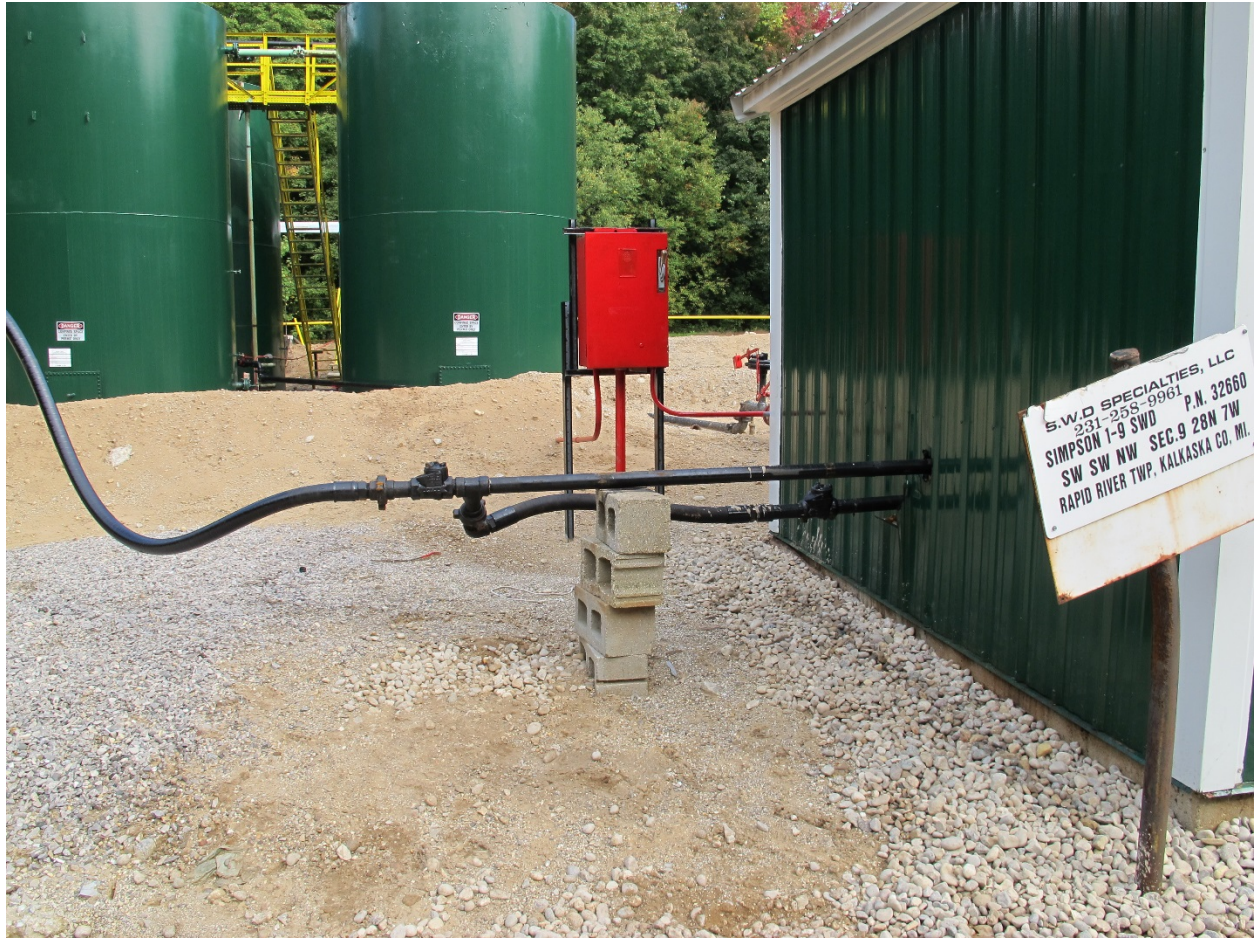
Above ground piping from the pump house to the well head is supported by cinderblocks (Attachment B, Figure 24). The tank battery and “clay lined” secondary containment area house six 400 bbl brine tanks. All injection fluid flows through aboveground steel piping brine to the injection well. All piping to the injection well was in good condition, and no signs of leaks were present (Attachment B, Figures 22, 24 - 25). The earthen berm or clay lined containment area appeared freshly shaped, and no sign of spills were present. The load station consists of a concrete pad, several flow lines, filter canisters to remove solids, and a vaulted trap to catch spill. Stains, oil residue, or other residual fluids appeared to be limited to the concrete pad at the load station.

Figure 24: IMG_0285, 9/25/14, 11:23 am (Eastern), Simpson #1-9 facility, well sign posted at pump house, tank battery and secondary containment area, piping from tanks to pump house supported with cinder blocks, pad appeared clean with no signs of spills, facing north.

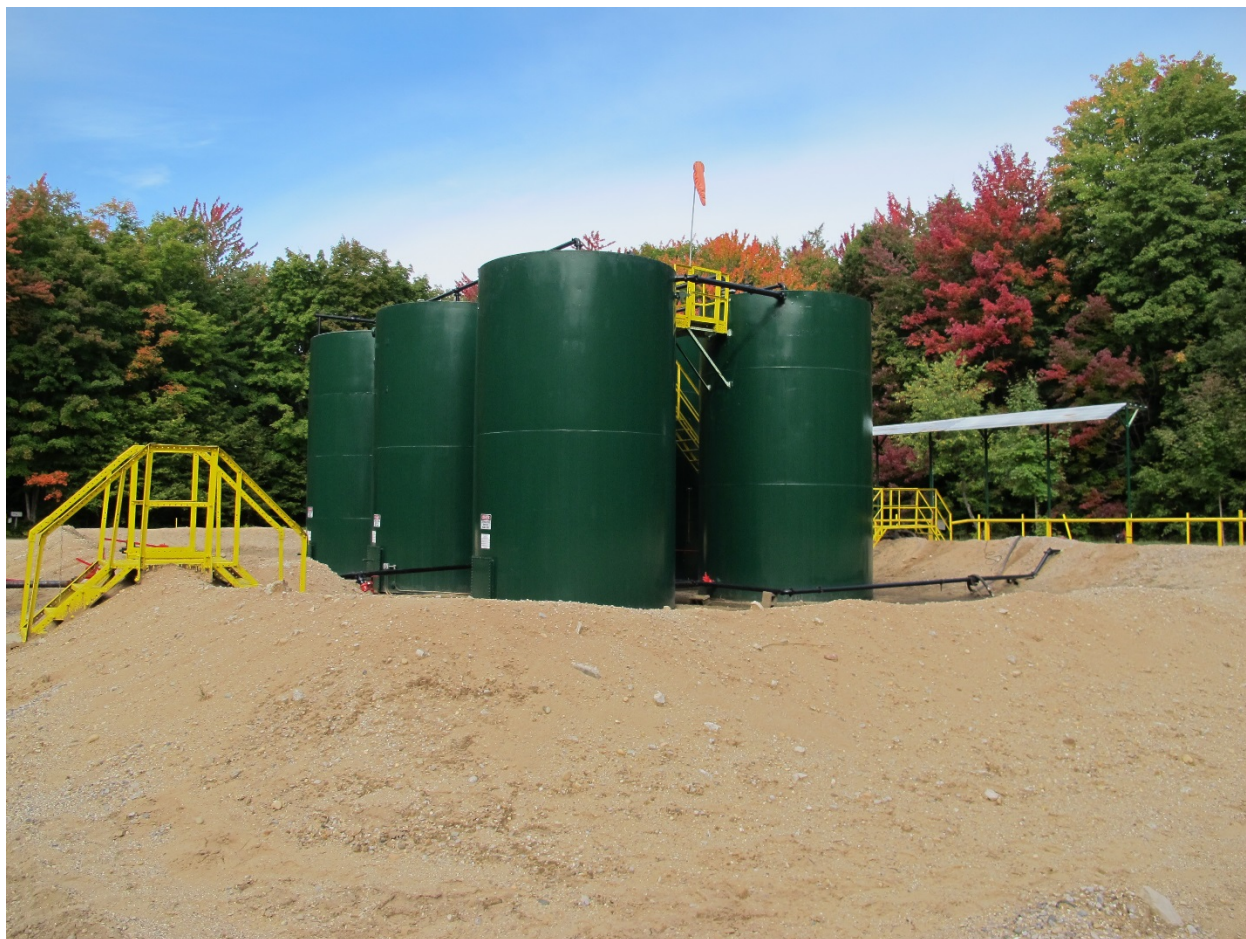
Figure 25: IMG_0286, 9/25/14, 11:23 am (Eastern), Simpson #1-9 facility tank battery and secondary containment, appeared clean with no signs of spills, facing west/northwest.
